Rimkus Consulting Group, Inc.
Eight Greenway Plaza, Suite 500
Houston, TX 77046
(800) 580-3228 Telephone
(713) 623-4357 Facsimile

Re: RCG File No: 11009971
LLV Number: 0209452
VMF Location: 1530 Greensmark Drive in Houston, Texas
Subject: Final Report

Rimkus Consulting Group, Inc. was retained to examine LLV 0209452, VIN 1GBCS10E4M2908832. The fire occurred on June 13, 2016 at around 12:30 P.M. the operator of the vehicle at the time of the fire, was unavailable for interview but reportedly stated the vehicle's engine died while delivering mail on his route and backfired during subsequent attempts to restart it. Soon thereafter, smoke was observed from beneath the hood as well as flames.

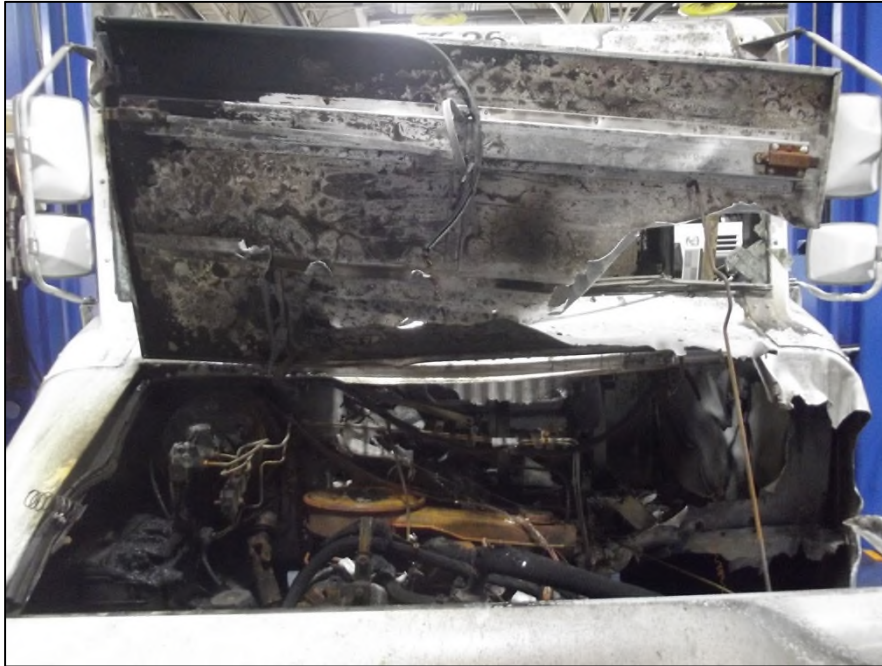
Photograph 5

Overall view of engine compartment.

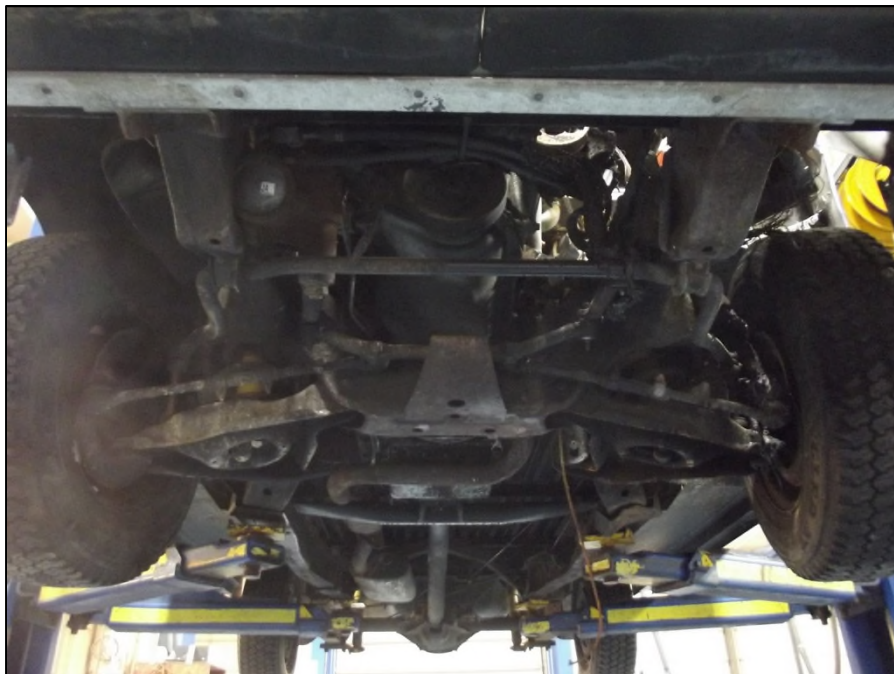
Photograph 6

Overall front view of undercarriage.

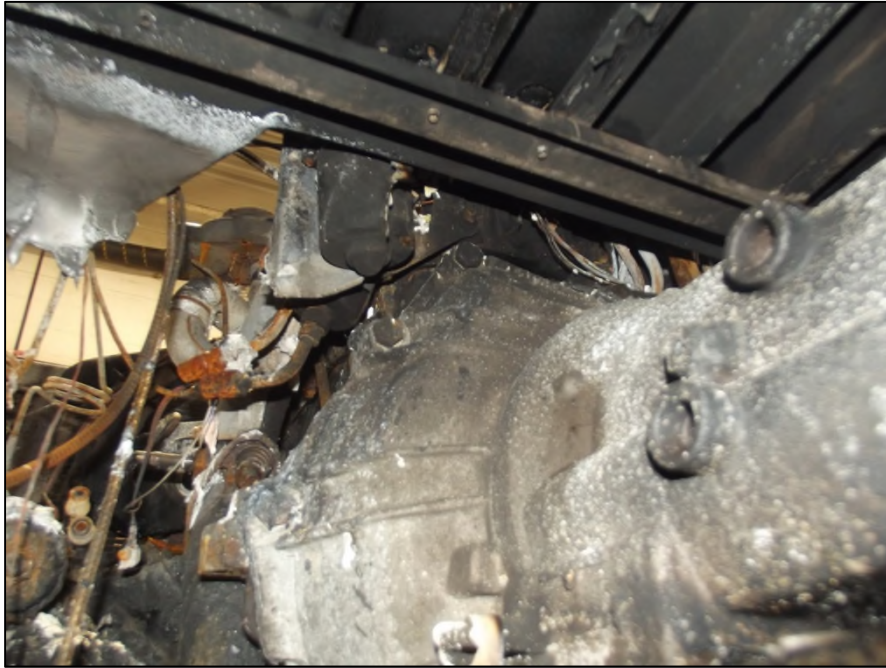
Photograph 7

View of area of origin from under the vehicle.

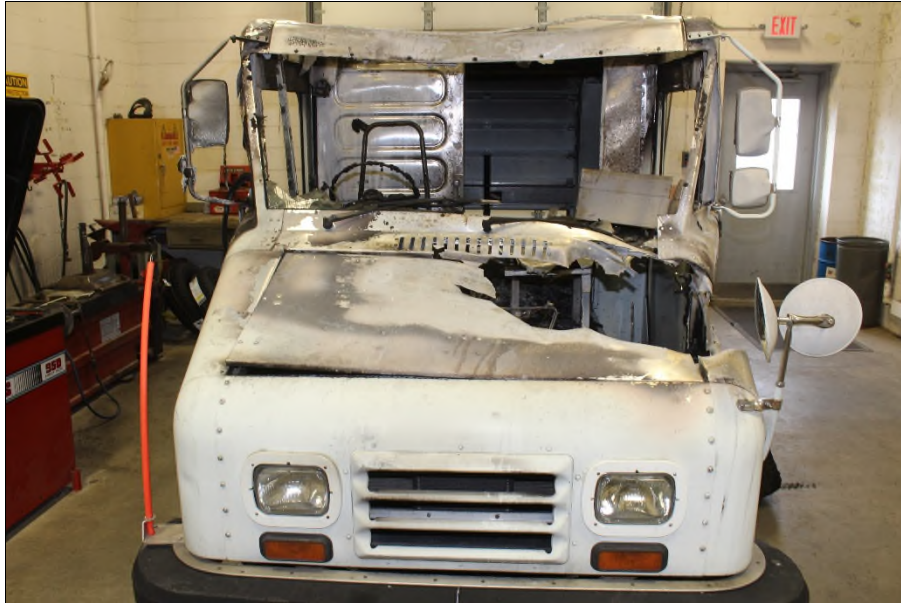
Photograph 1

Front of the vehicle with heat and direct fire damage. All patterns indicated the fire originated in the engine compartment and extended out to the other areas of the vehicle.

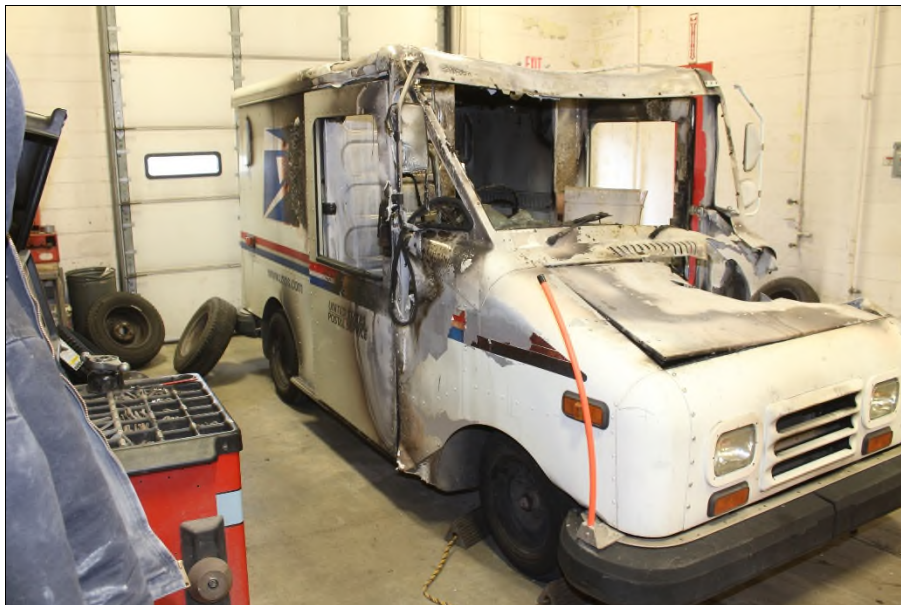
Photograph 2

Driver side of the vehicle with smoke, heat, and direct fire damage. All patterns indicated the fire originated in the engine compartment and extended to the other areas of the vehicle.

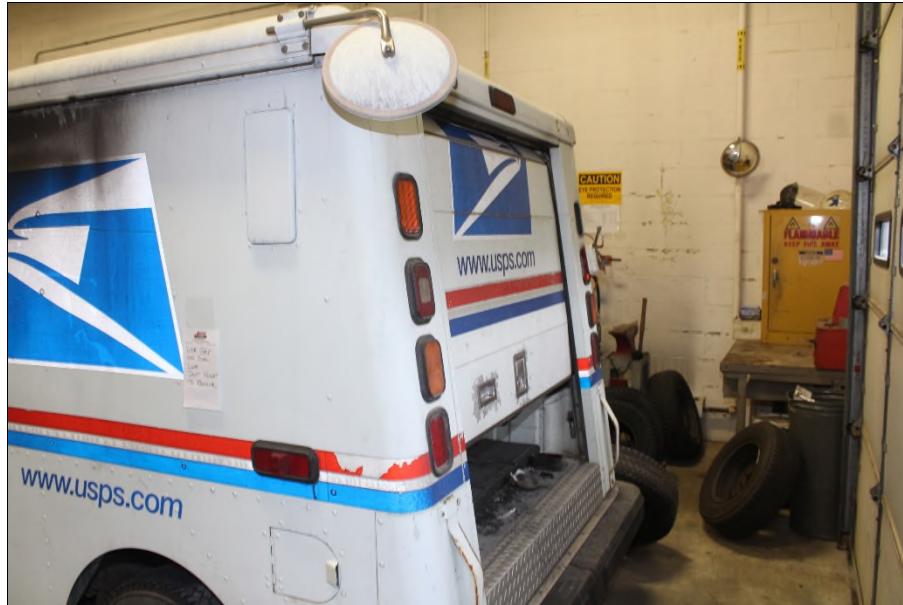
Photograph 3

Rear of the vehicle with smoke damage.

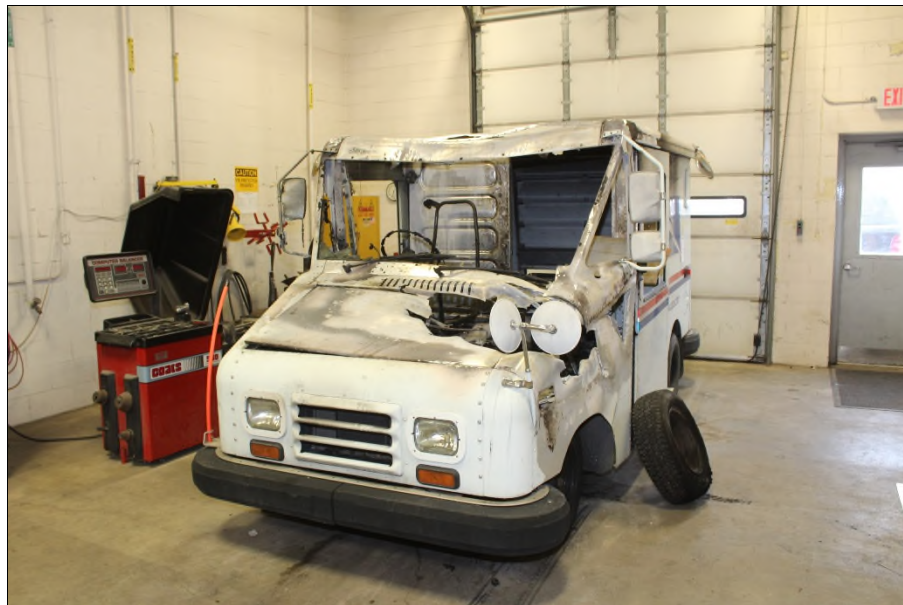
Photograph 4

Mail side of the vehicle with heat and direct fire damage. All patterns indicated the fire originated in the engine compartment and extend out to the exterior of the vehicle.

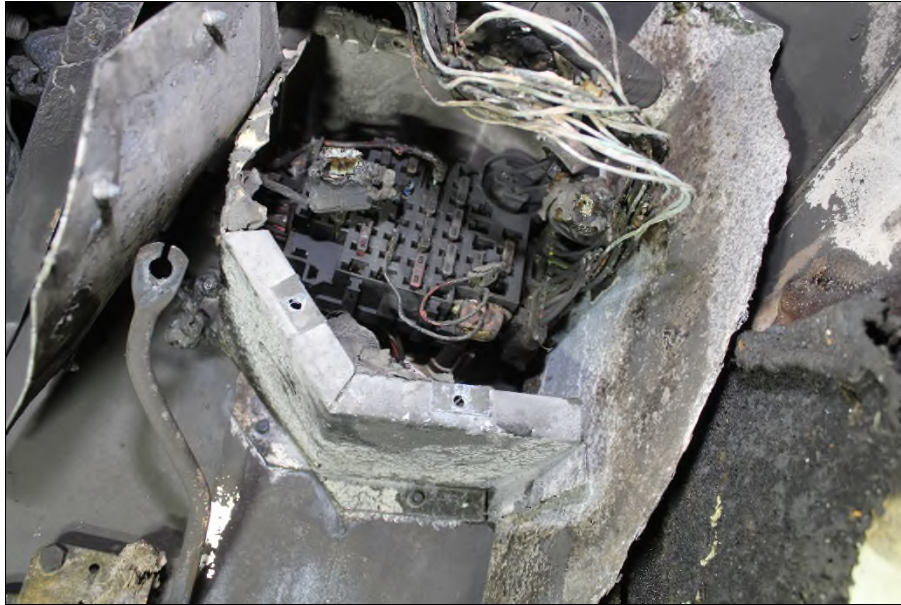
Photograph 5

Fuse block intact. Testing of fuses indicated that several were blown as a result of the fire.

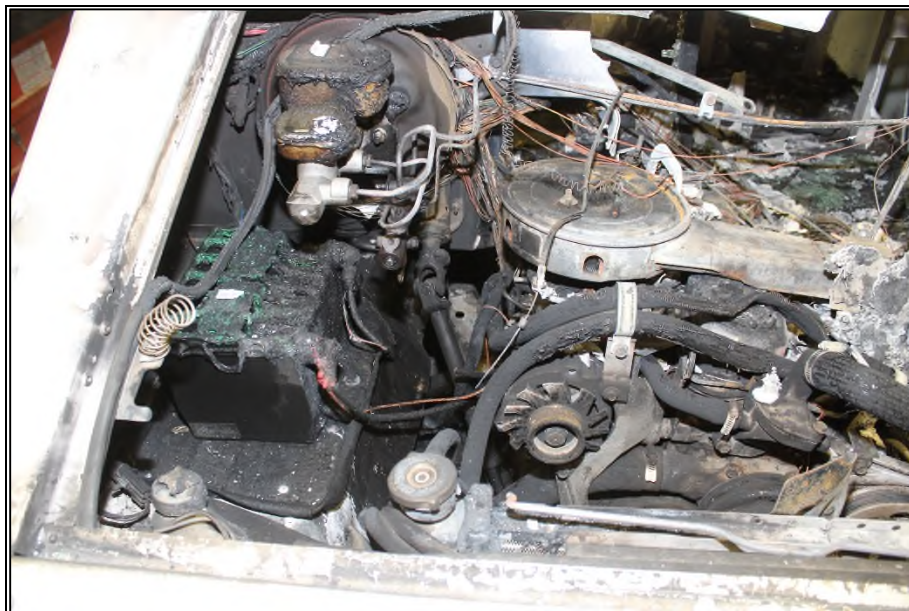
Photograph 6

Driver side of the engine compartment with heat and direct fire damage. All patterns indicated the fire originated on the mail side and traveled to the driver side.

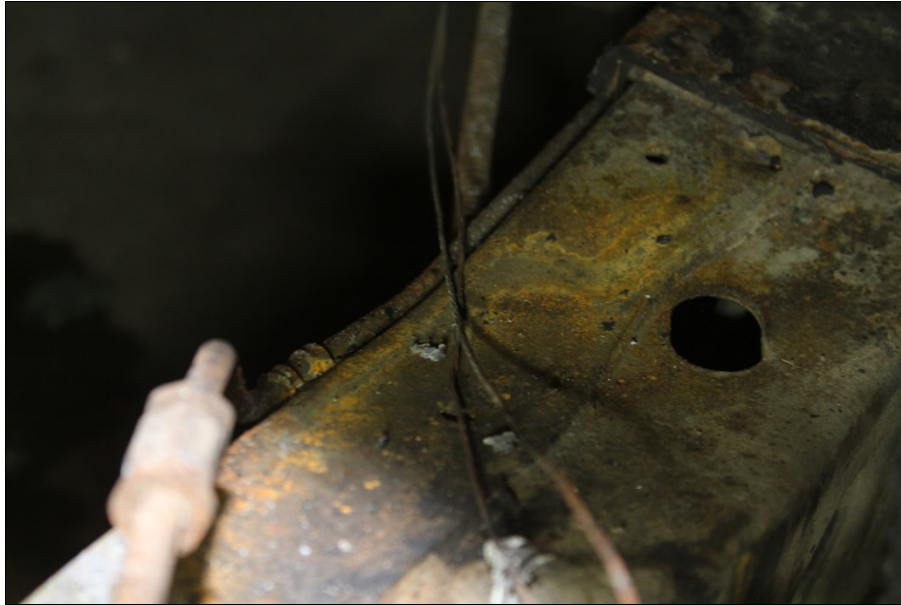
Photograph 7

Irregular shaped oxidation pattern on the frame of the vehicle. Pattern is indicative of fuel running down the frame.

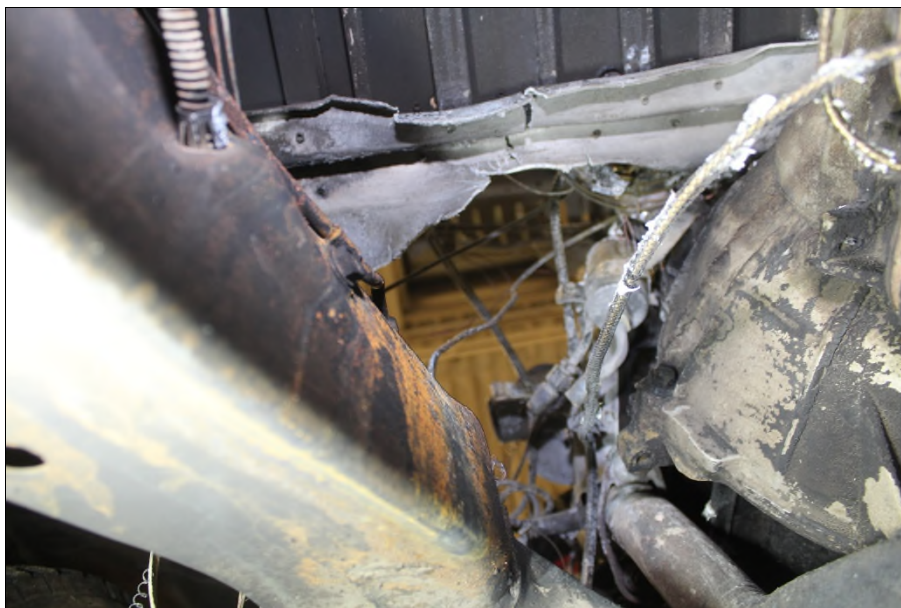
Photograph 8

Undercarriage below area of origin with irregular shaped oxidation pattern on the frame.

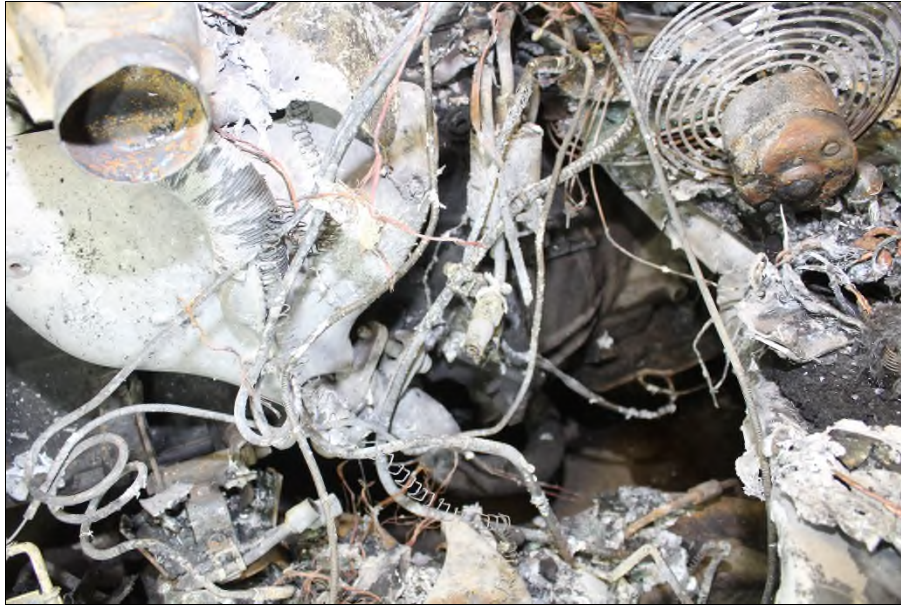
Photograph 9

Area of origin was the mail side of the engine compartment where the flexible fuel lines make connection with the rigid fuel lines.

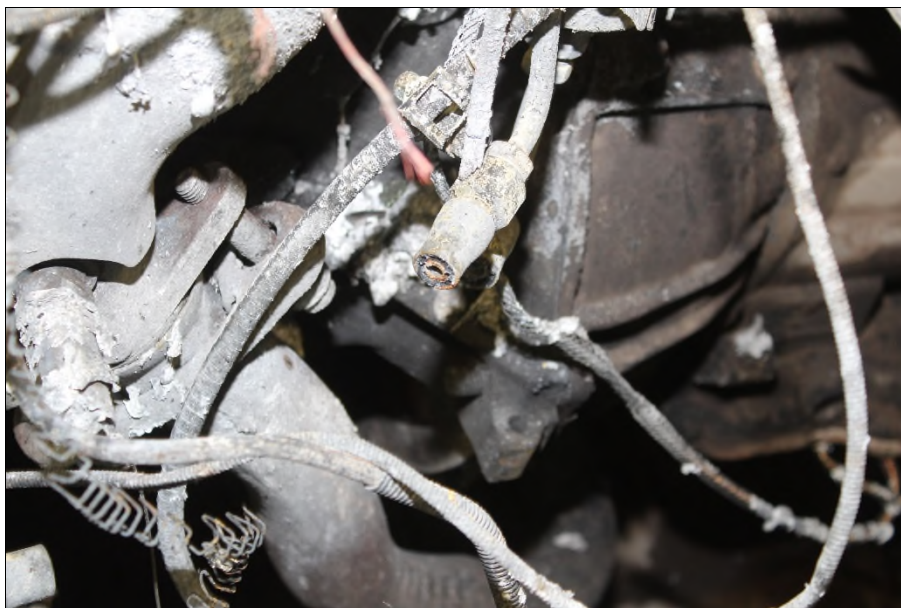
Photograph 10

Connection between flexible fuel line and rigid fuel line in the area of origin.

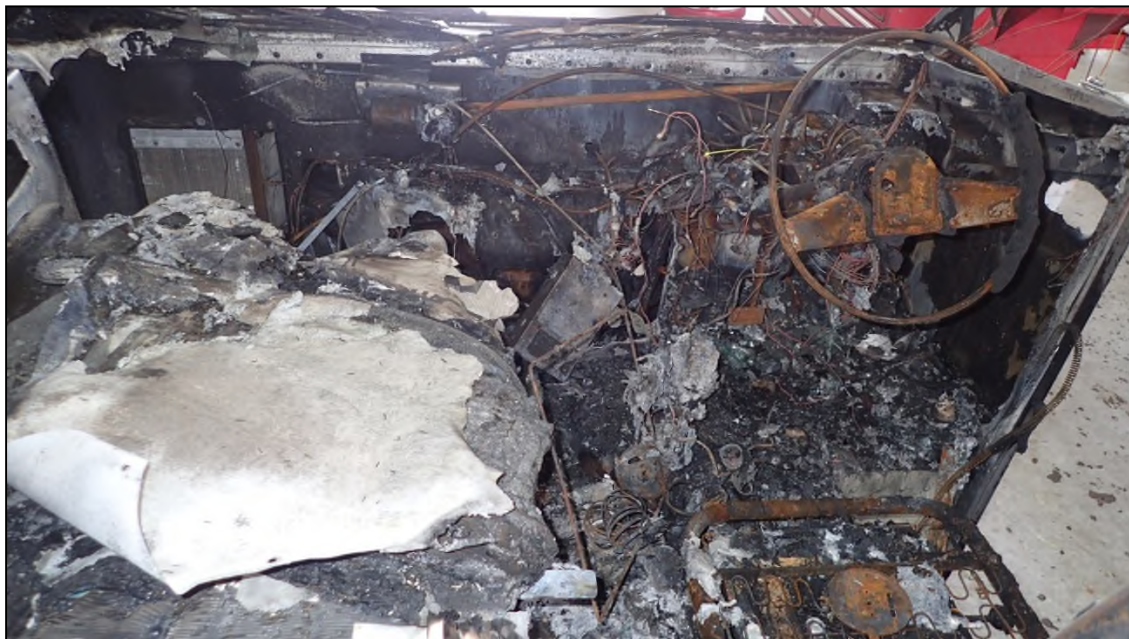
Photograph 4

Inspection of the interior revealed the most severe fire damage had occurred in the dashboard area on the vehicle. The majority of the combustible materials in and around the dashboard area had been consumed during the fire event. The fire damage progressed from the interior to the cargo area of the LLV. Burned remains of the headlamp switch assembly were recovered from the floor of the vehicle.

View of the dashboard area.

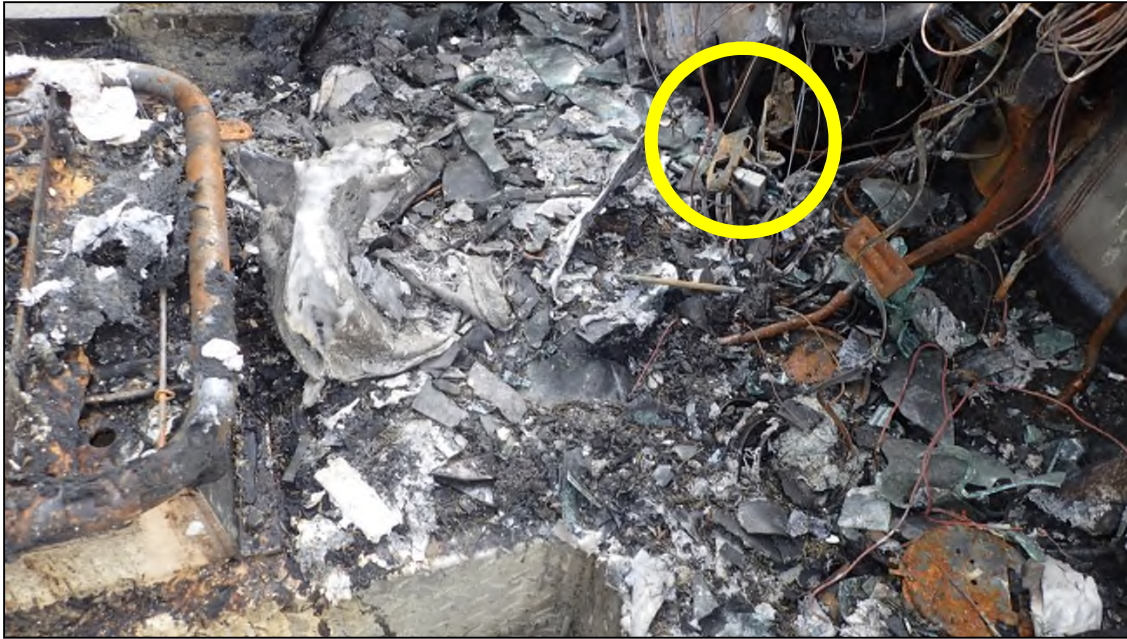
Photograph 5

3. The specific ignition sequence and cause of the fire was determined to be the direct result of a failure of the rheostat switch within the headlamp switch which heated and ignited surrounding combustible material.

View of the headlamp switch in the fire debris.

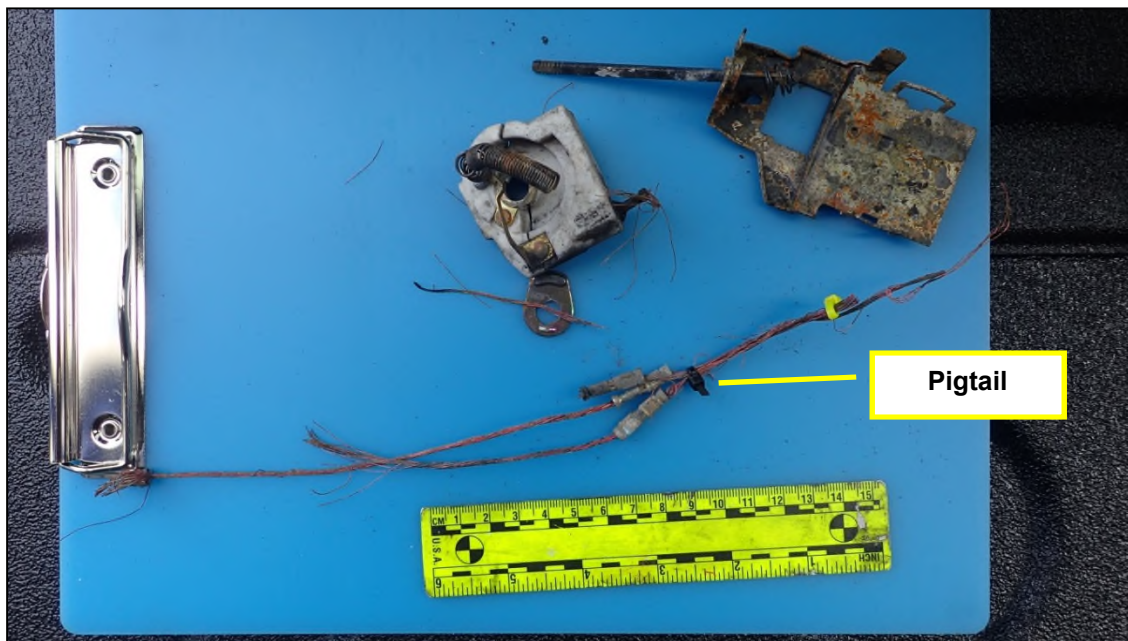
Photograph 6

View of the headlamp switch and pigtail listed as evidence Item A.

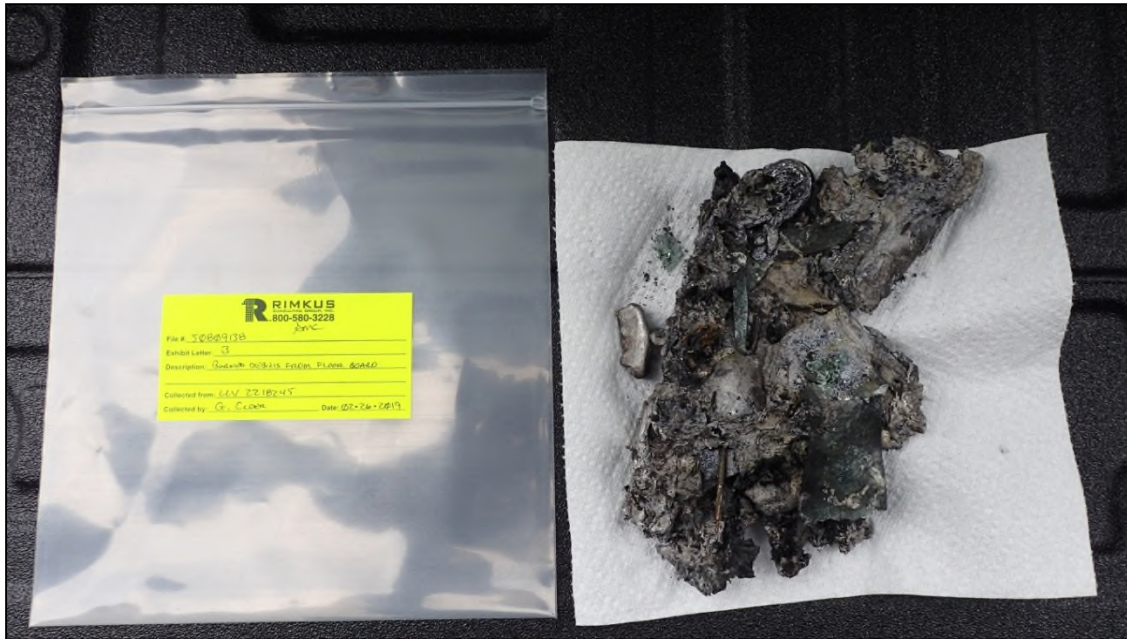
Photograph 7

View of the fire debris listed as evidence Item B.

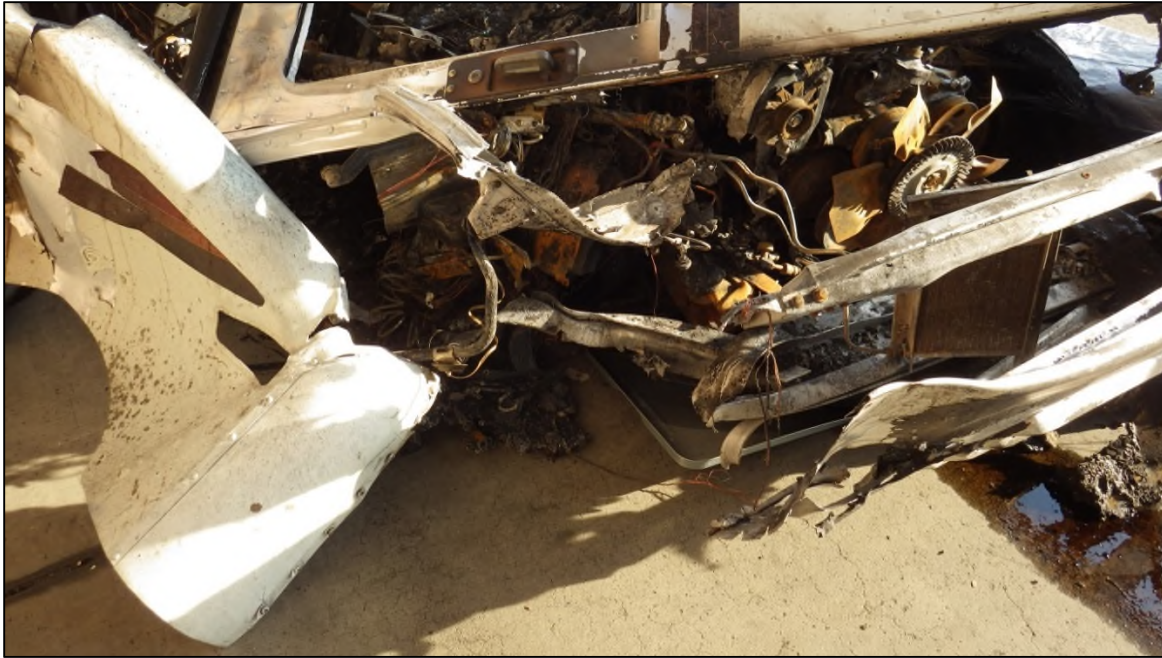
Photograph 3
Crash impact area.

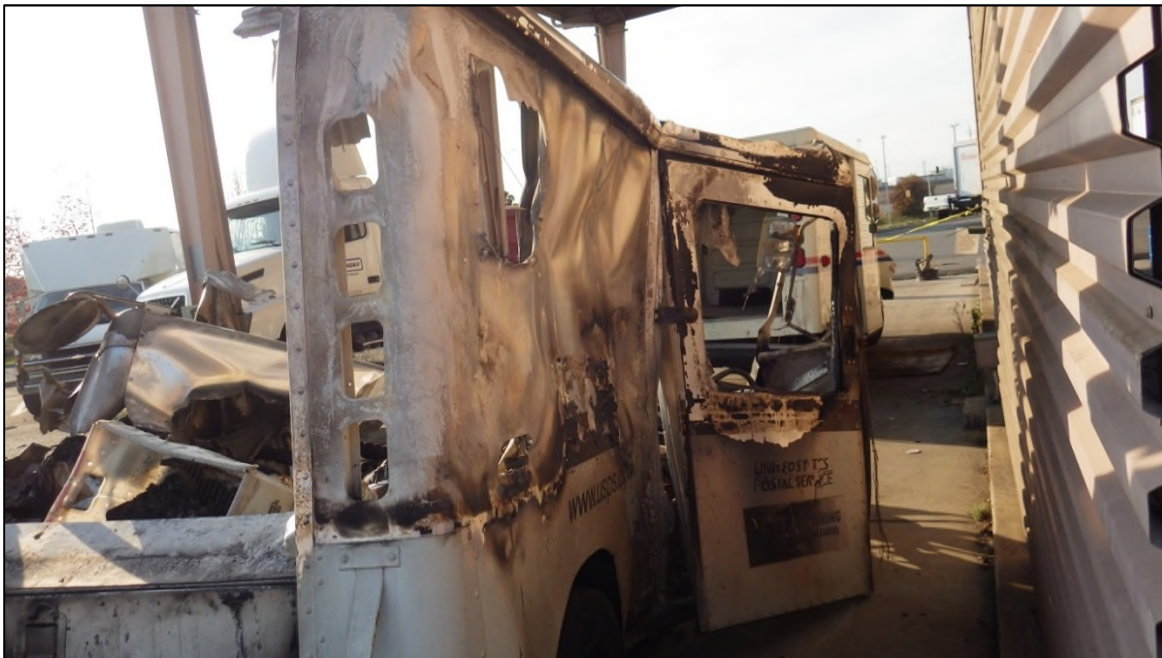
Photograph 4
Driver's side showing displaced door.

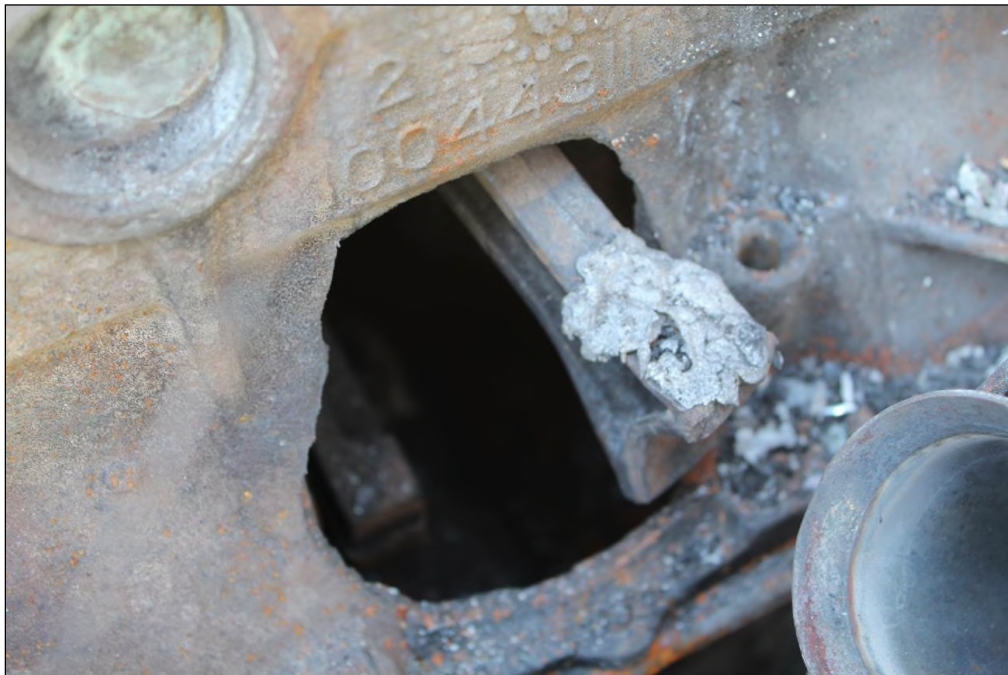
Photograph 4

Exhaust manifold removed and connection rod exposed.

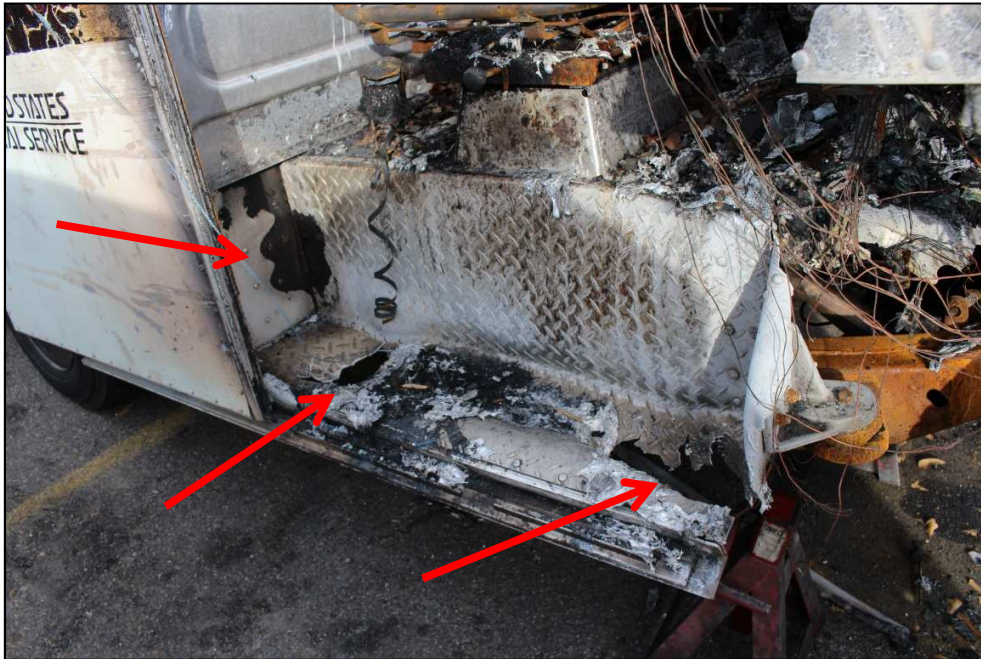
Photograph 5

Fire damage to right step area.

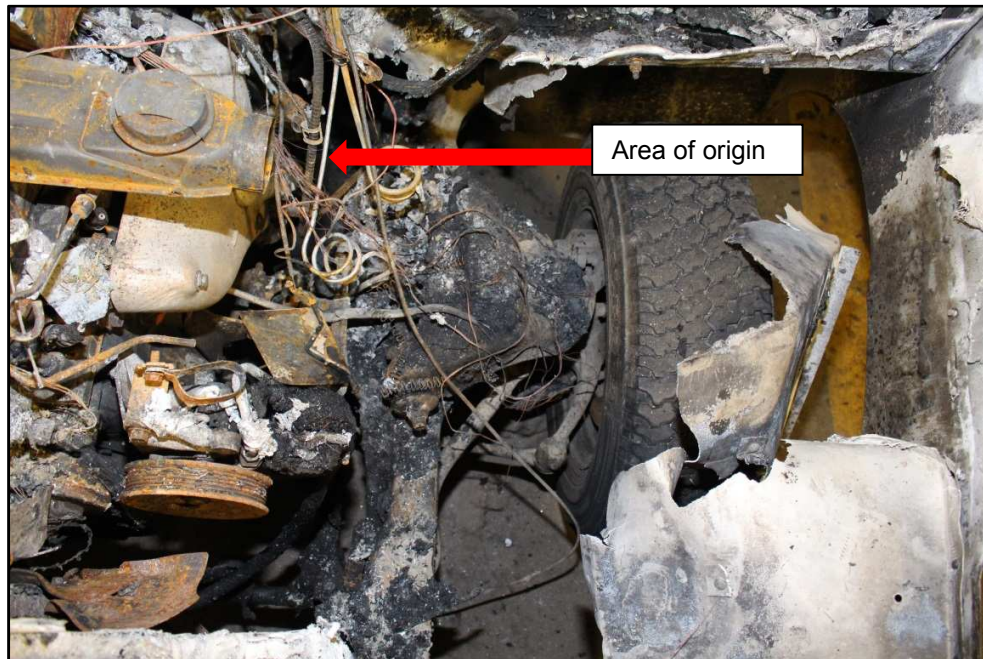
Photograph 3

Engine compartment from above.

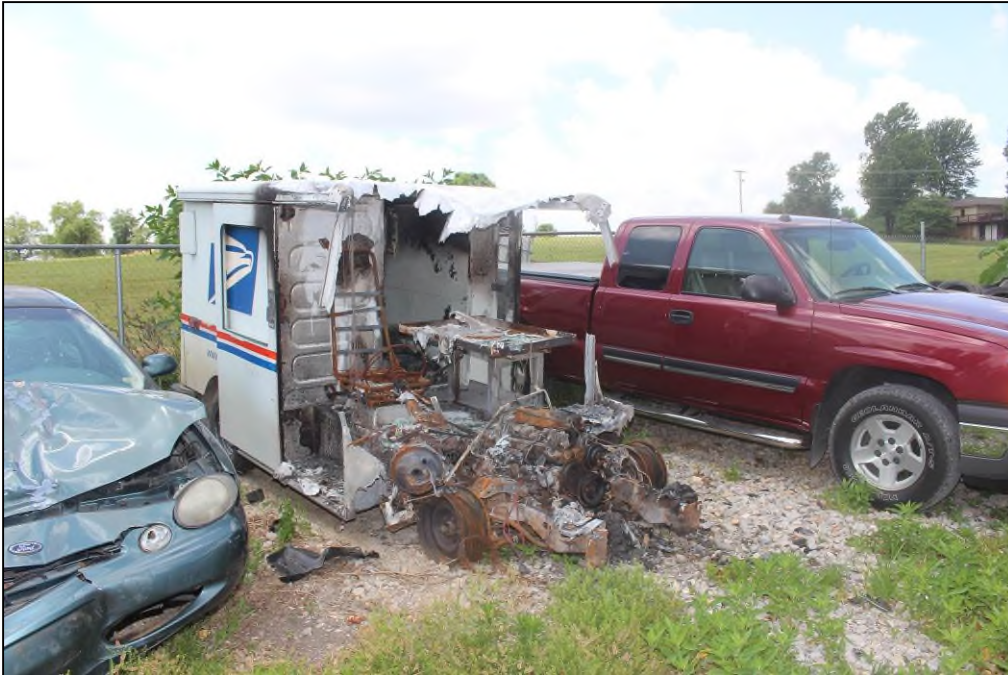
Photograph 1

View of the vehicle from the front right corner.

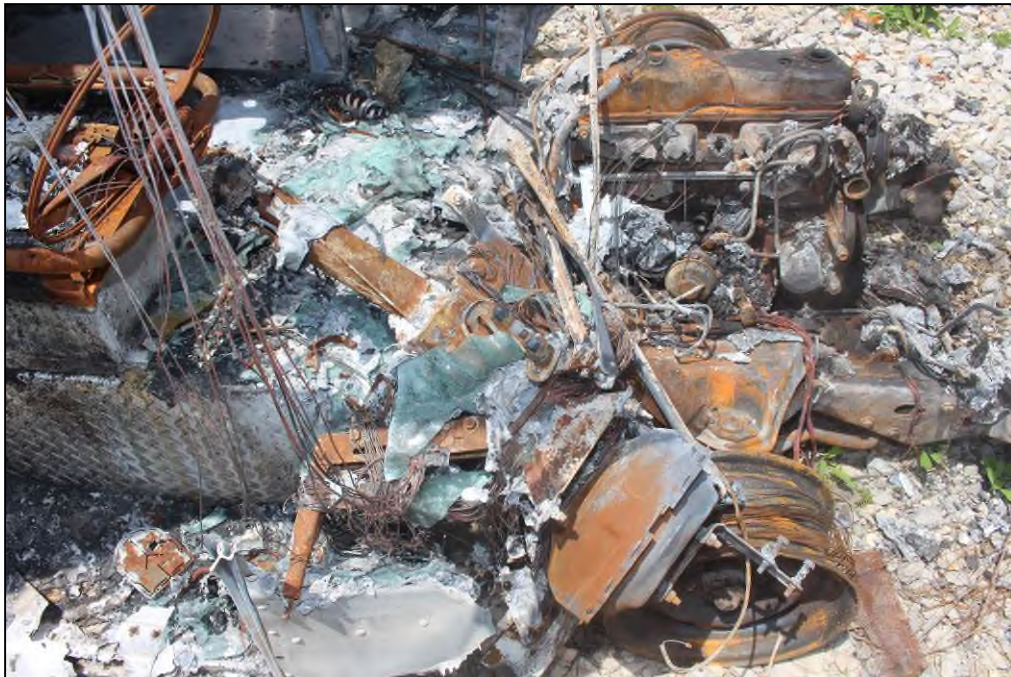
Photograph 3

View of right side of the engine compartment.

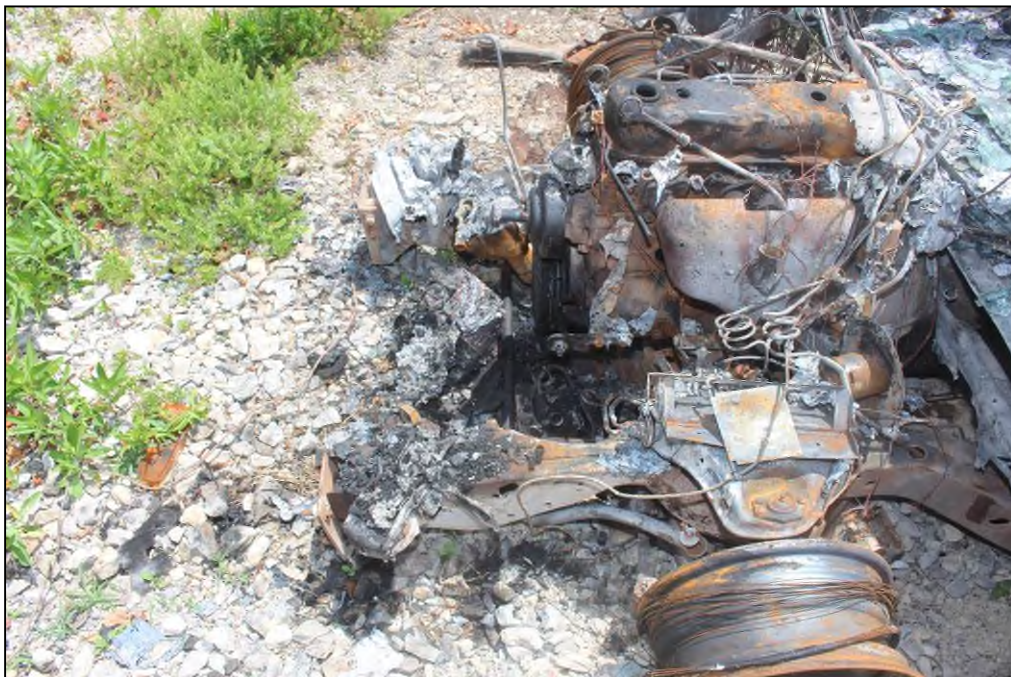
Photograph 4

Burn patterns observed in the engine compartment confirmed the fire originated in the front left area of the engine compartment and progressed upward and outward throughout the engine compartment and into the mail and cargo compartments.

View of the left side of the engine compartment.

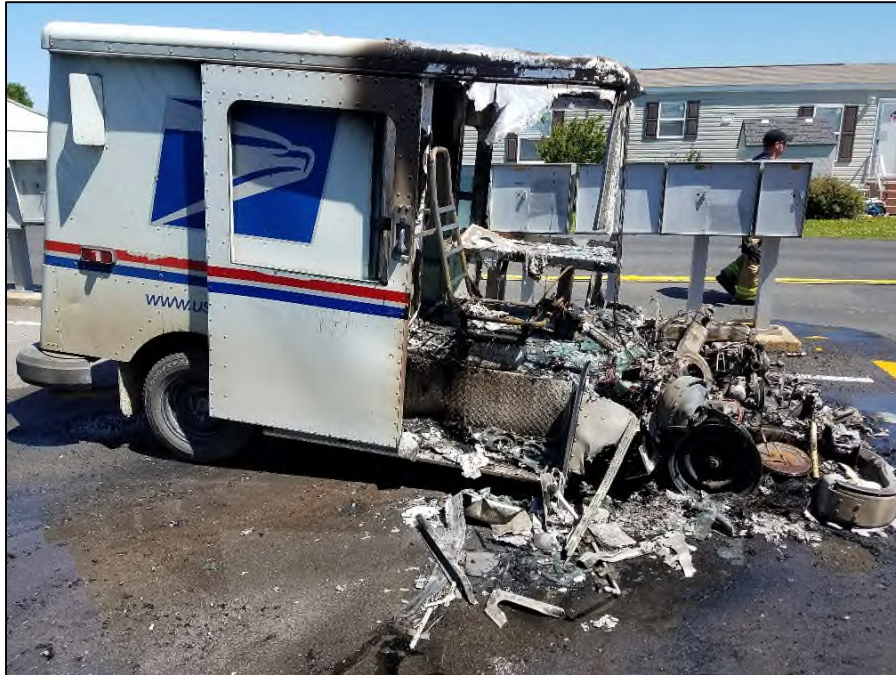
Photograph 5

A view of the LLV at the time of the fire.

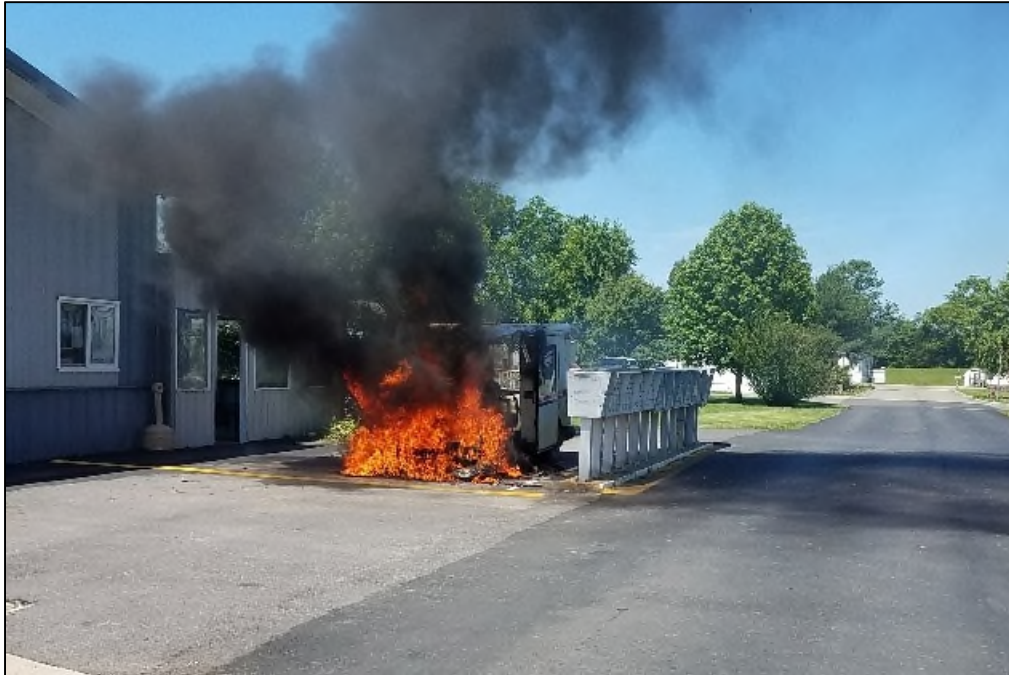
Photograph 7

The LLV at the time of the fire.

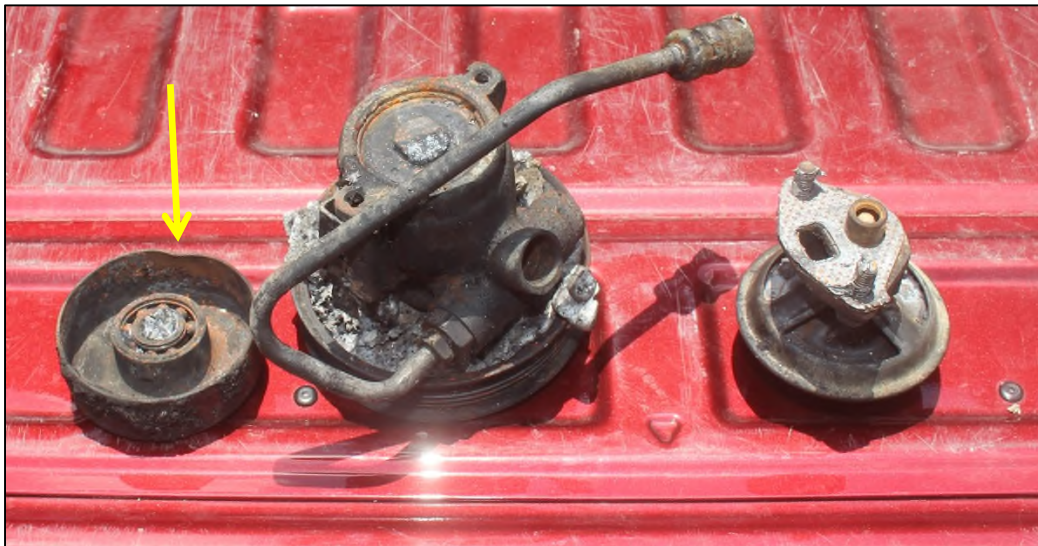
Photograph 8

3. The point of origin could not be conclusively identified at the time of our examination due to the severe fire damage to the engine compartment and the lack of remaining physical evidence for examination.
4. The specific ignition sequence and cause of the fire could not be conclusively determined at the time of our examination due to the severe fire damage to the engine compartment and the lack of remaining physical evidence for examination.
5. We could not eliminate the possibility of an engine fluid leak (IE: fuel, oil, transmission fluid) onto a hot engine surface as the possible cause of the fire or a failure of the fan belt pulley system.

The engine components collected; observe the mechanical damage to the pulley.

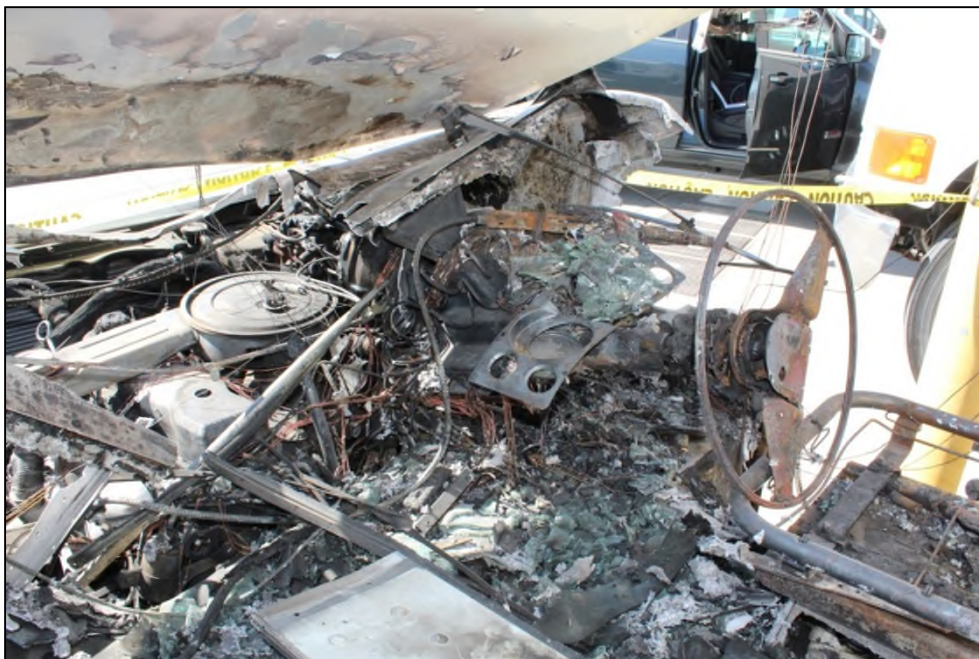
Photograph 2
Fire damage to interior compartment.

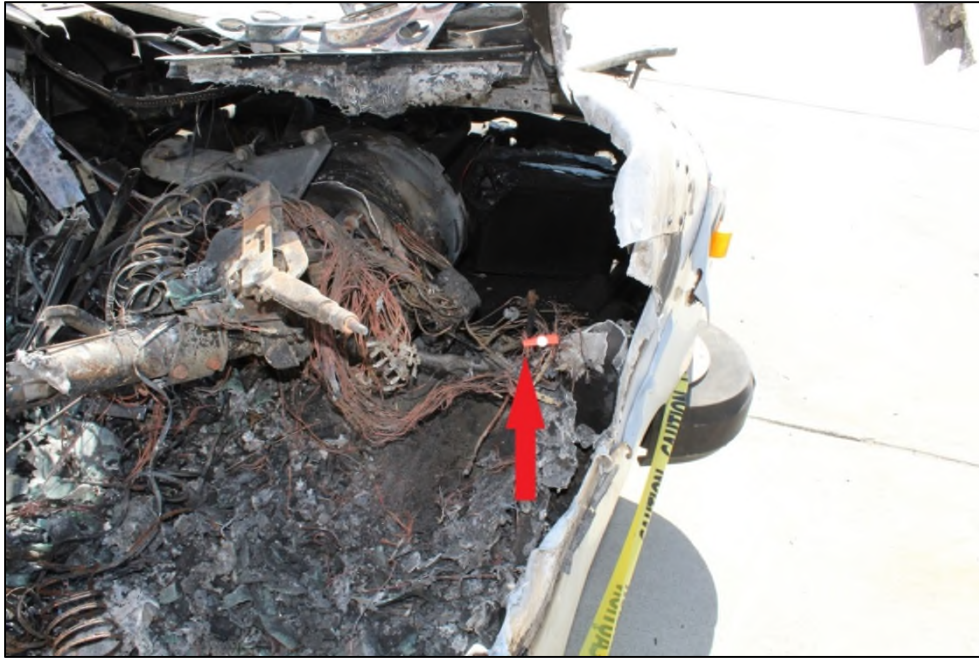
Photograph 3

Electrical activity on wiring in dashboard area (red arrow).

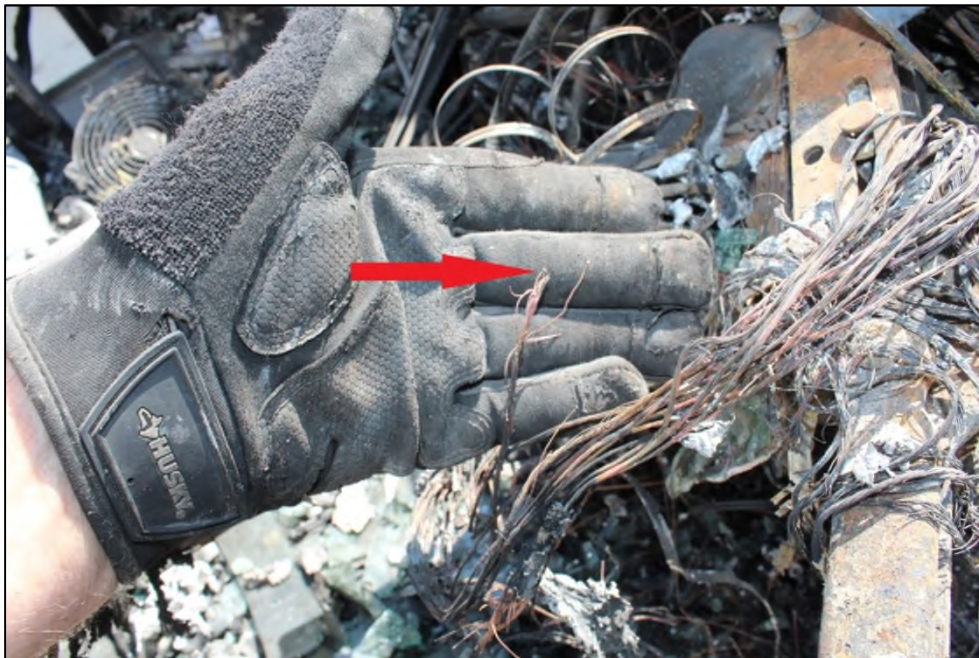
Photograph 4

Electrical activity on wiring in dash area (red arrow).

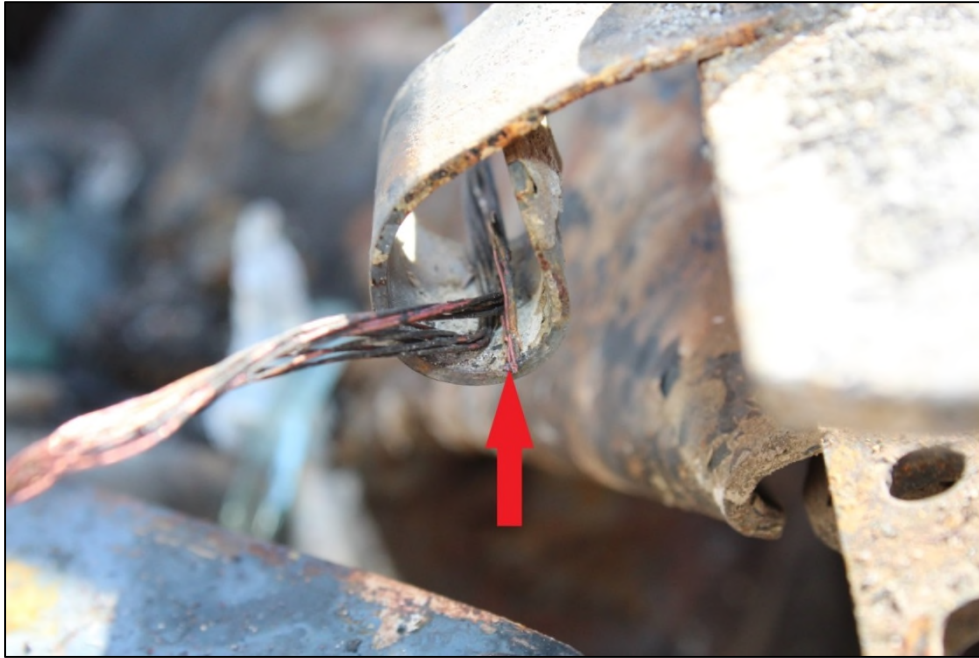
Photograph 5

Electrical activity at clamp on e-brake handle.

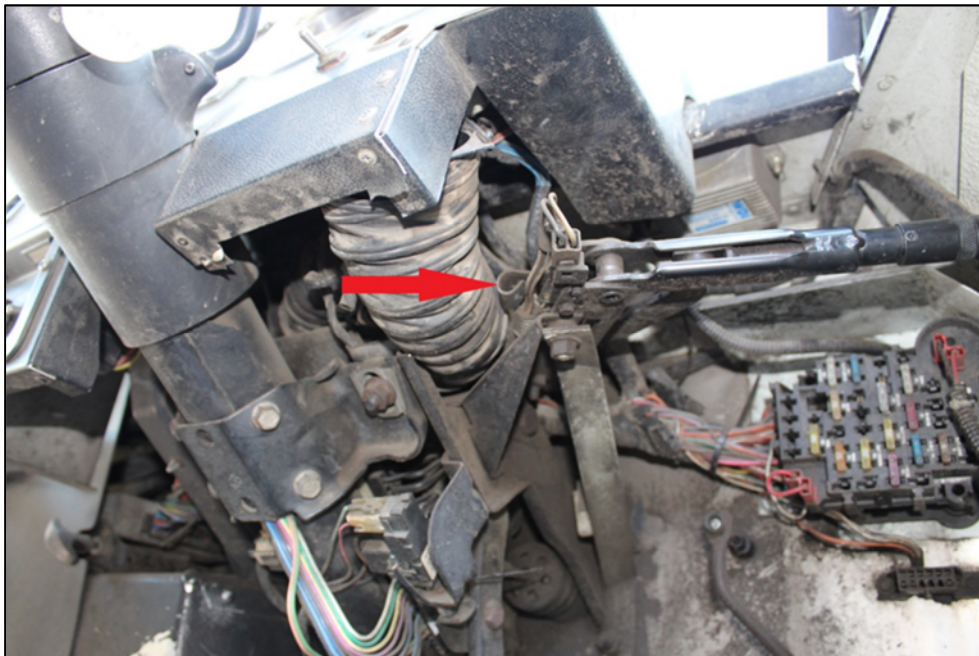
Photograph 6

E-brake conductors and clamp on exemplar vehicle.

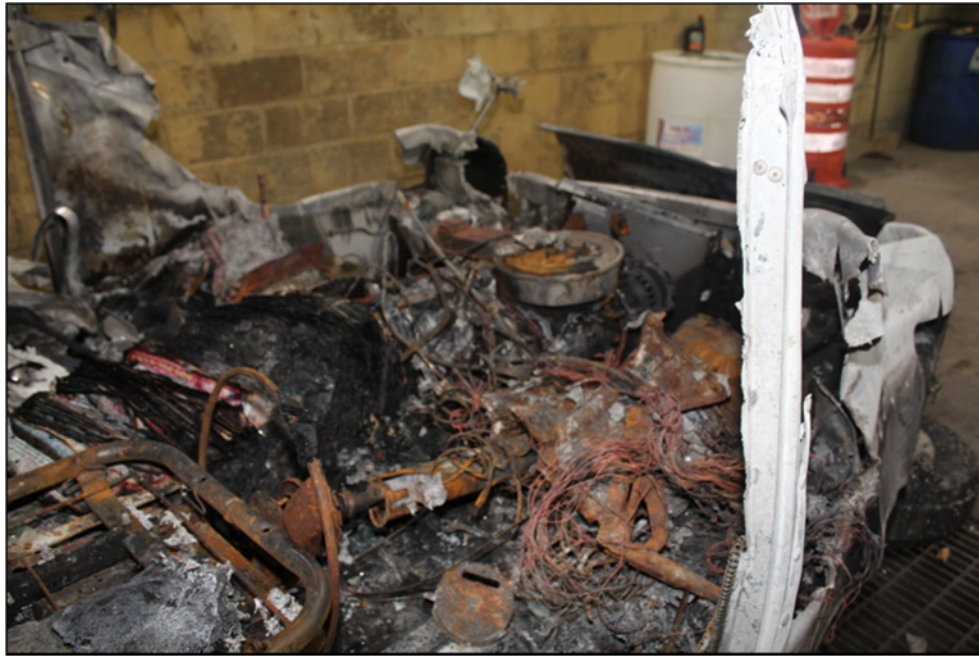
Photograph 9
Area of origin.
